A THING OF BEAUTY

GUIDELINES FOR PROTECTING THE HISTORIC ARCHITECTURE
OF THE WEST BERGEN - EAST LINCOLN PARK HISTORIC DISTRICT
JERSEY CITY, NEW JERSEY

Published by
Jersey City Historic Preservation Commission
To Be Adopted

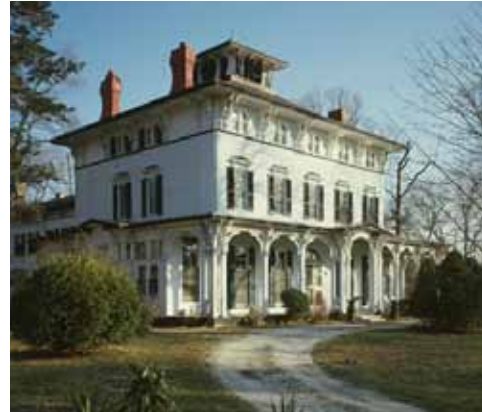
George Allen House
Cape May, NJ
HABS

- An emphasis on repetitive vertical forms, emphasizing height of windows and doors.
- Low pitched roofs with wide overhanging eaves with large decorative cornices and elaborate brackets.
- The use of arches, especially the Roman or round arch. The segmented (or flattened arch) was common for windows and doors as well as interior door trim and mantle surrounds.
- Squared forms for windows and doors, part of the classical renaissance vocabulary, were also used, sometimes as a hold-over from the Greek Revival.
- Long stoops and tall doorways with impressive surrounds were common features.
- Porches or verandahs as well as towers or belvederes (also known as a widow's walk) were common features.
- Deep setbacks from the street often helped to emphasize pretensions of the building.

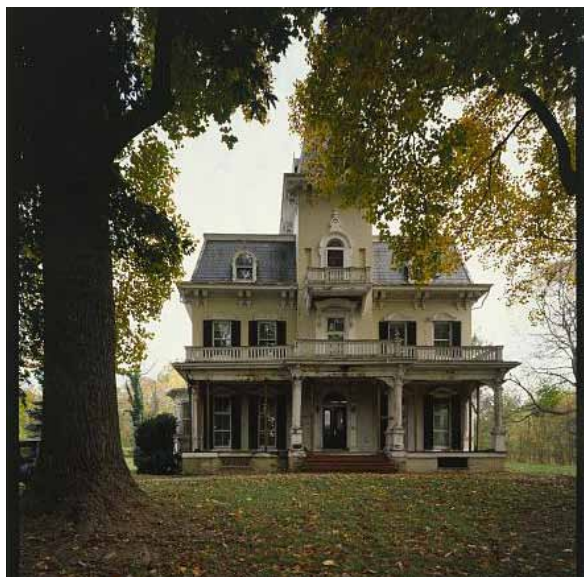
Gambrill House - Frederick, MD - HABS

The roof style is most often supported on the deep bracketed cornice of the Italianate style while the rest of the building below usually continued the Italianate-Renaissance Revival theme.

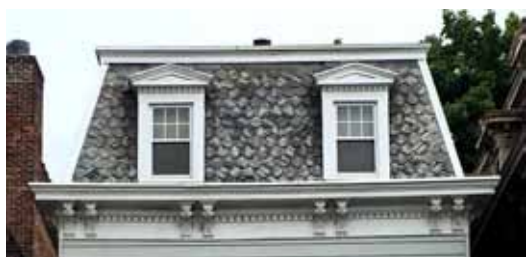
Distinctive Mansard Roof: Dual-Pitched, and Hipped, with slate roof and dormers.

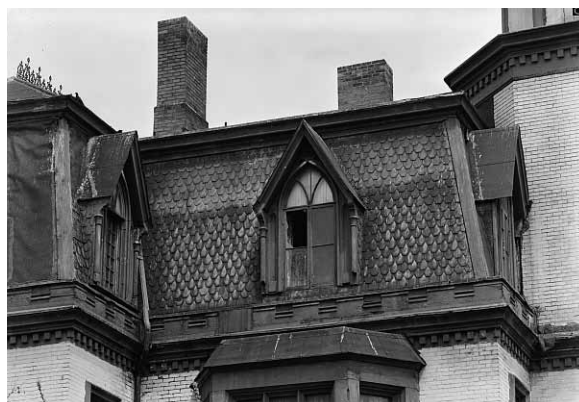
Cary House - Buffalo, NY - HABS
Another fine example of a Mansard roof.

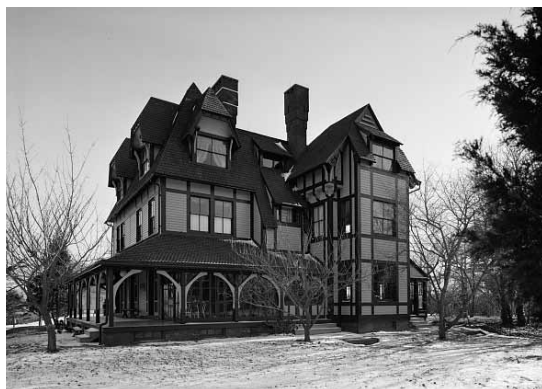
- Gabled roofs, usually steeply pitched, with decorative trusses and vergeboards
- Overhanging eaves with exposed rafter ends
- Wooden wall cladding known as stickwork – patterns of horizontal, vertical, or diagonal boards proud of the wall plane for emphasis and decoration
- Townhouse variants usually relied on vertical stickwork with small sections of ornament in other patterns
- Applied, decorative detailing with multi-textured surfaces and exposed false (applied) structural members reminiscent of Medieval half-timbering
- One story porch, either entry or full width

Emlen Physick House - Stick Style
Cape May, NJ - HABS

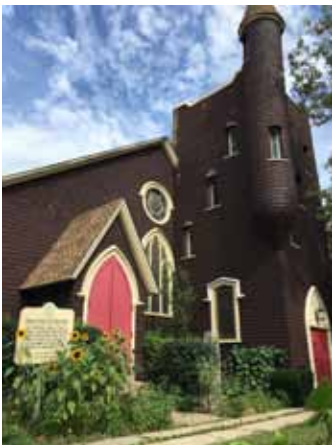
Moses Bulkley House
Southport, CT
HABS

Vertical Emphasis

Heavily
Decorative
Vergeboard

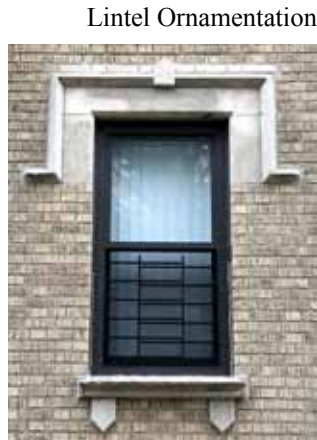
Lintel Ornamentation

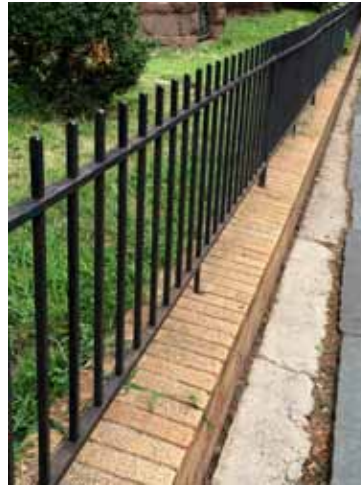
Iron should never come in direct contact with concrete because of a propensity for iron to spall due to the acidic nature and dampness of concrete masonry. Usually iron was buffered in lead, whereas today, epoxies perform the same task.

- Avoid filling hollow parts of cast iron with concrete or another material. During freeze/thaw cycles, concrete will absorb water and expand, pushing apart the iron.

- To keep rust from developing inside cast iron components, make sure to keep joints tight and well caulked against moisture intake.

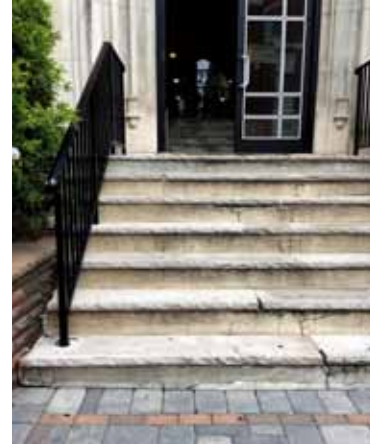
Basic Parts of a Porch

- **Foundation**, usually masonry
- **Flooring**, usually tongue-in-groove wood
- **Steps**, primarily masonry but also often wood, especially when associated with frame houses.
- **Railing and Balustrades**, wood, stone, metal
- **Pillars and/or Supports** usually wood, masonry, and metal in some instances.
- **Roof** generally frame with flat seamed metal or shingle roofs

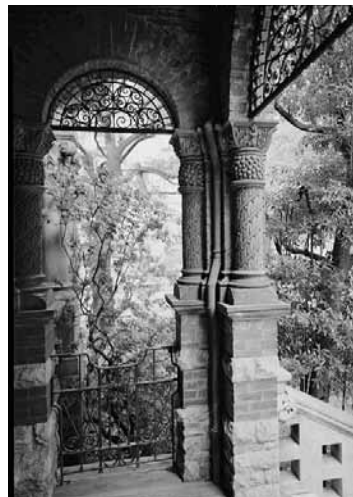
803 Whitaker Street - Savannah, GA
HABS

Porches are especially subject to decay because of their exposure to sun, wind, moisture, and freeze/thaw cycles.

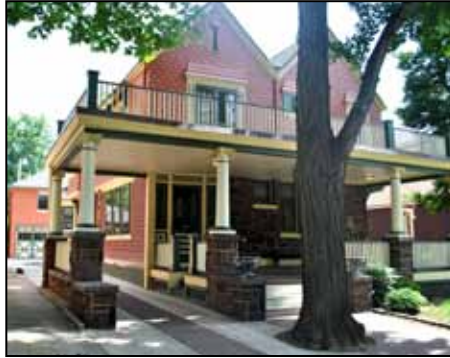
Ornamentation on porches can range from simple to ornate, depending on the architectural style. Note the port cochere at the left.

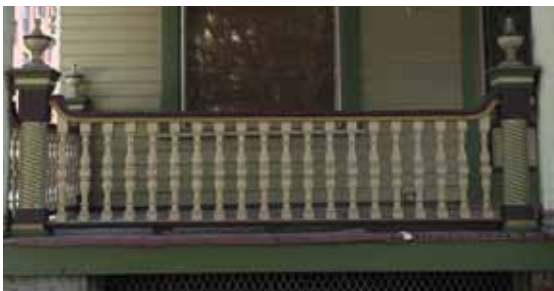
Balustrades are the railings found along the porch perimeter and stairs, made up of balusters (the vertical elements), a handrail, and often a bottom rail.

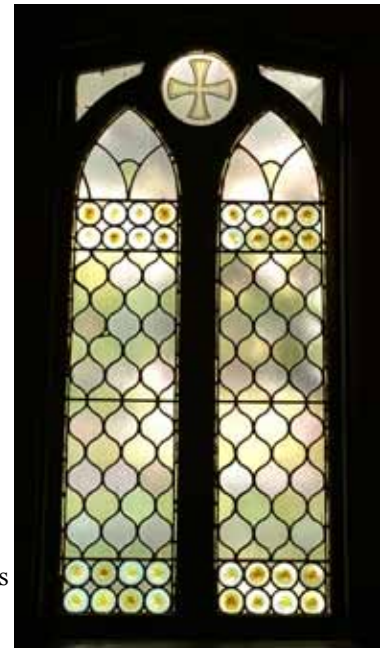
A window from the narthex of St. Paul's Church in Bergen.

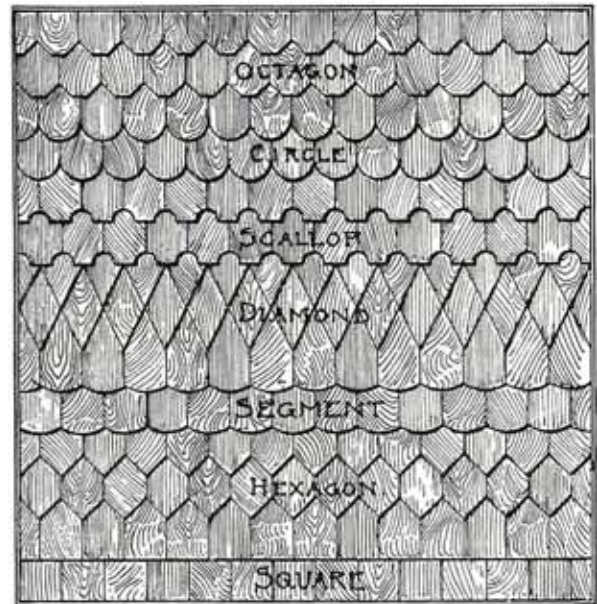
Various Shingle Styles - From Robert's Illustrated Millwork Catalog, 1903.

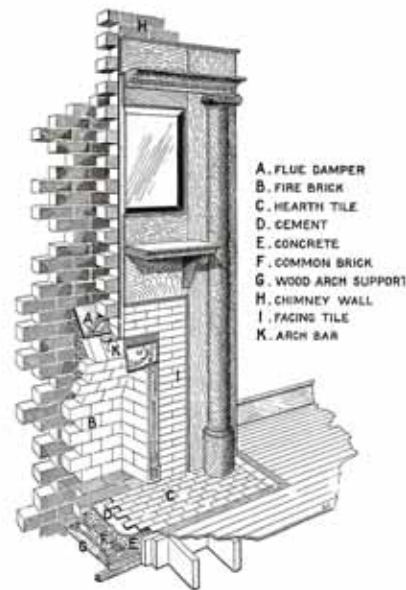
From Robert's Illustrated Millwork Catalog (1903), depicting a brick fireplace with a wood mantle.

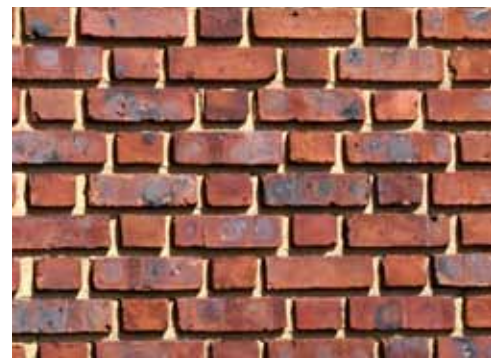
Clinker brick - Temple Beth El - Jersey City, NJ
Flemish Bond Pattern

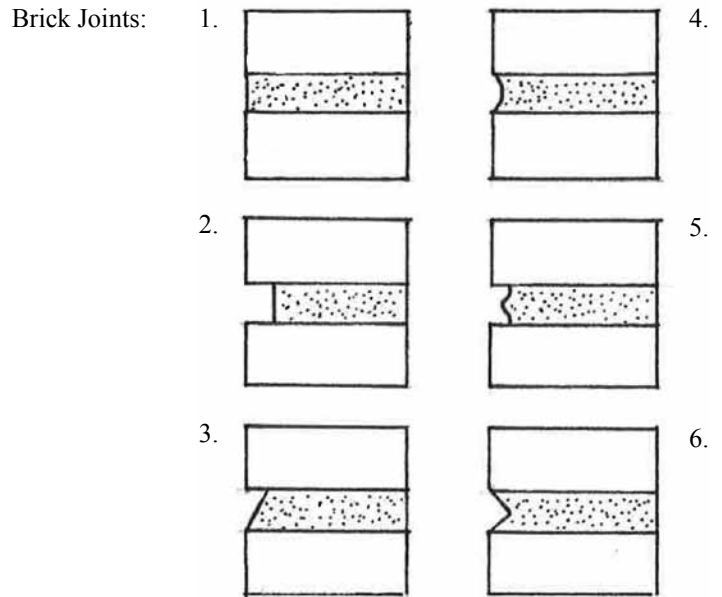
1. Flat or Flushed Joint – Scraping the end of the wet mortar so that it is flush with the face of the brick.
2. Recessed Joint – Some of the mortar is removed leaving a deep shadow. A unique appearance, but can cause water build up so it should be tooled to a smooth finish.
3. Struck or Weathered Joint – A recessed top and flush lower edge, smooth water resistant surface, that creates shadows which can affect appearance.
4. Keyed Joint (or “bucket-handle” joint) – Has a concave appearance formed by drawing a tool with a curved edge along the joint. This motion compresses the mortar and allows for good water run-off.
5. Beaded Joint - Tooled to create a central ridge.
6. V-Shaped Joint - Struck into a V shape to allow for water run-off.

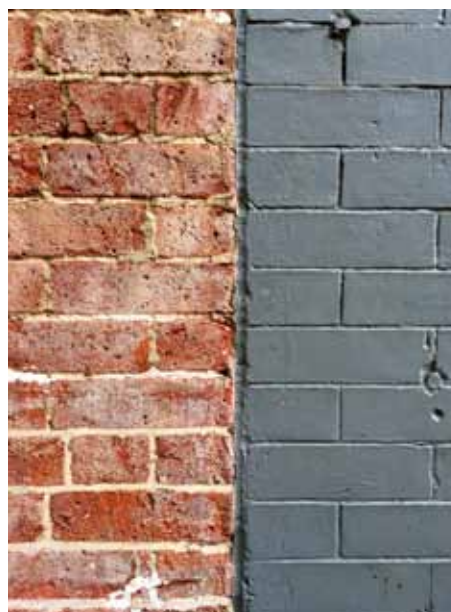
Sandblasted

Not Sandblasted

Mechanical grinding, scraping, and sandblasting, along with the use of high-pressure washing, and extremely caustic and reactive chemicals result in short-term improved appearance, but long-term detriment to the historic material. Abrasive and aggressive cleaning methods result in the loss of historic material, making the building more vulnerable to decay. This is especially true of brick, which when fired is given a natural fire-rating. Sandblasting destroys this fire-rating, significantly decreasing its life expectancy. Sandblasting masonry is unacceptable because it exposes the soft inner core of the brick, turning a relatively non-porous material into a very porous surface. Moisture always follows the path of least resistance, and will saturate the masonry, causing further problems that certainly outweigh the negative appearance of a dirty building.

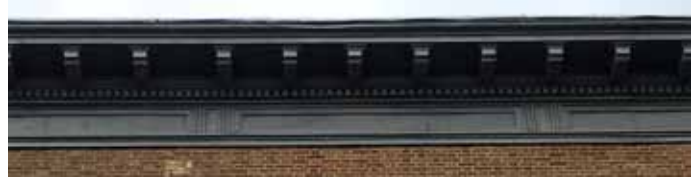
Williams Building - San Fransisco, CA ~ HABS

Maintenance, Repair, and Replacement

- If failed paint is present, the cornice should be scraped gently, and loose, delaminated paint disposed of safely. Wet scraping or sanding methods are recommended.

- The existing cornice may be made weathertight by caulking, and repainted to match the existing color in a semi gloss or gloss finish.
- For consistency and to help better portray the unity of the monumental façade of the row, it is strongly recommended that the cornice, lintels, sills, and stoop be painted in a color that closely resembles the original underlying brownstone material of the building trim, and the original color of the cornice.

- Limited replacement in kind of deteriorated, irreparable or missing elements is approved if new work matches the historic in material, design, size, shape, and profile.

- The cornice is to be repaired based on site and photographic evidence. The use of concrete stucco and spray foam insulation to replace missing elements and ornament is prohibited.

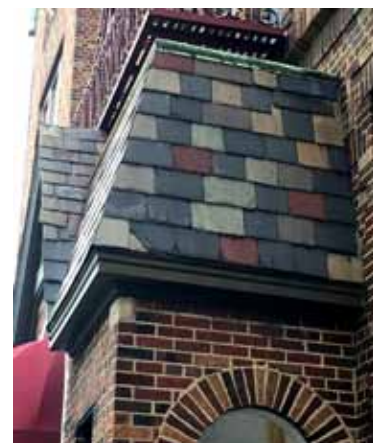
As technology improved throughout the course of the 19th Century, metal began to be used as a roofing material. The adaptability and malleability of metal proved advantageous to usage at ornamental roofing areas, such as domes and turrets, rather than other heavier materials. By the mid 19th Century, metal roofing materials began to be manufactured on a large scale.

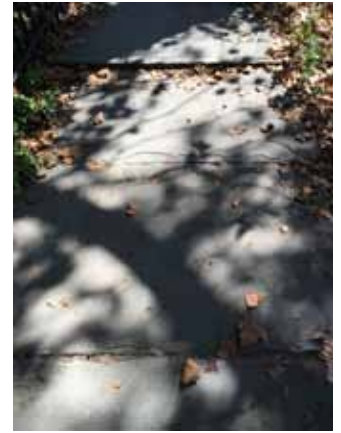
- When bluestone is laid with its bedding plane vertical, the layers can begin to chip off because of structural instability. Though this method of construction is initially less expensive, the cost of future repairs does not make it an affordable option.
- Bluestone should only be cleaned with alkaline-based cleaners as it reacts negatively to acidic cleaners.
- Due to its fragile nature, bluestone usually cannot be repaired. However, appropriate, in-kind replacements can be found as there are still quarries in operation.

- It is always recommended to study a restoration project in a historic district with the entirety of the neighborhood in mind. Some methods and materials may be appropriate for one house, but not for another.
- Tree roots, age, and erosion can cause deterioration and displacement of bluestone sidewalks and pavers.
- Urban pollution (such as carbon monoxide) can also further deterioration in stone.
- Similar to other masonry materials, bluestone is also susceptible to efflorescence, the absorption of moisture containing salt that leads to salt crystallization on the interior of the material, resulting in material loss.

Avoid using salt to melt ice and snow during the winter. Heavy use of de-icing salts can introduce salt into the building material, beginning the process of efflorescence. Shovel around historic building materials, or use de-icing salt sparingly, only to break up unmanageable sections of ice to facilitate shoveling.

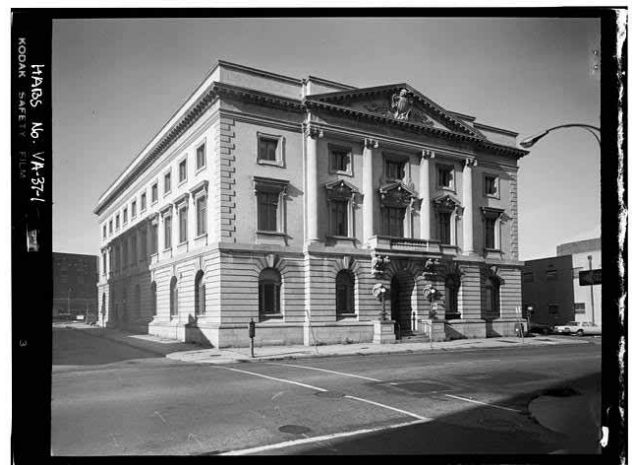
United States Post Office - Norfolk, VA - HABS

The rhythm of the facade is indicated by a repetition of forms, all in proportion to each other.

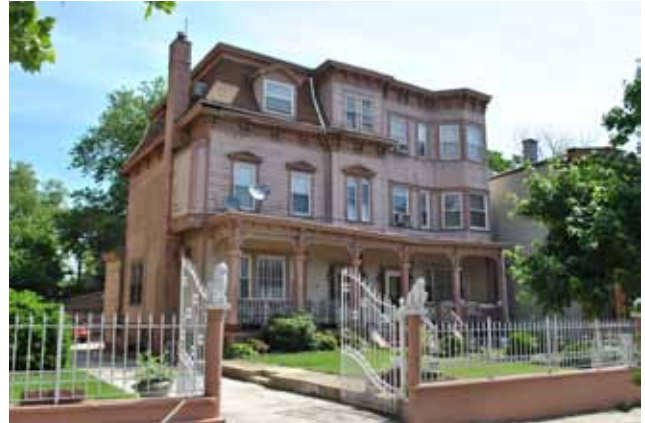
An example of Additive Massing
